# **INDOOR AIR QUALITY ASSESSMENT**

**Winchester Fire Department  
32 Mount Vernon Street  
Winchester, Massachusetts**

Prepared by:  
Massachusetts Department of Public Health  
Bureau of Environmental Health Assessment  
Emergency Response/Indoor Air Quality Program  
October, 2003

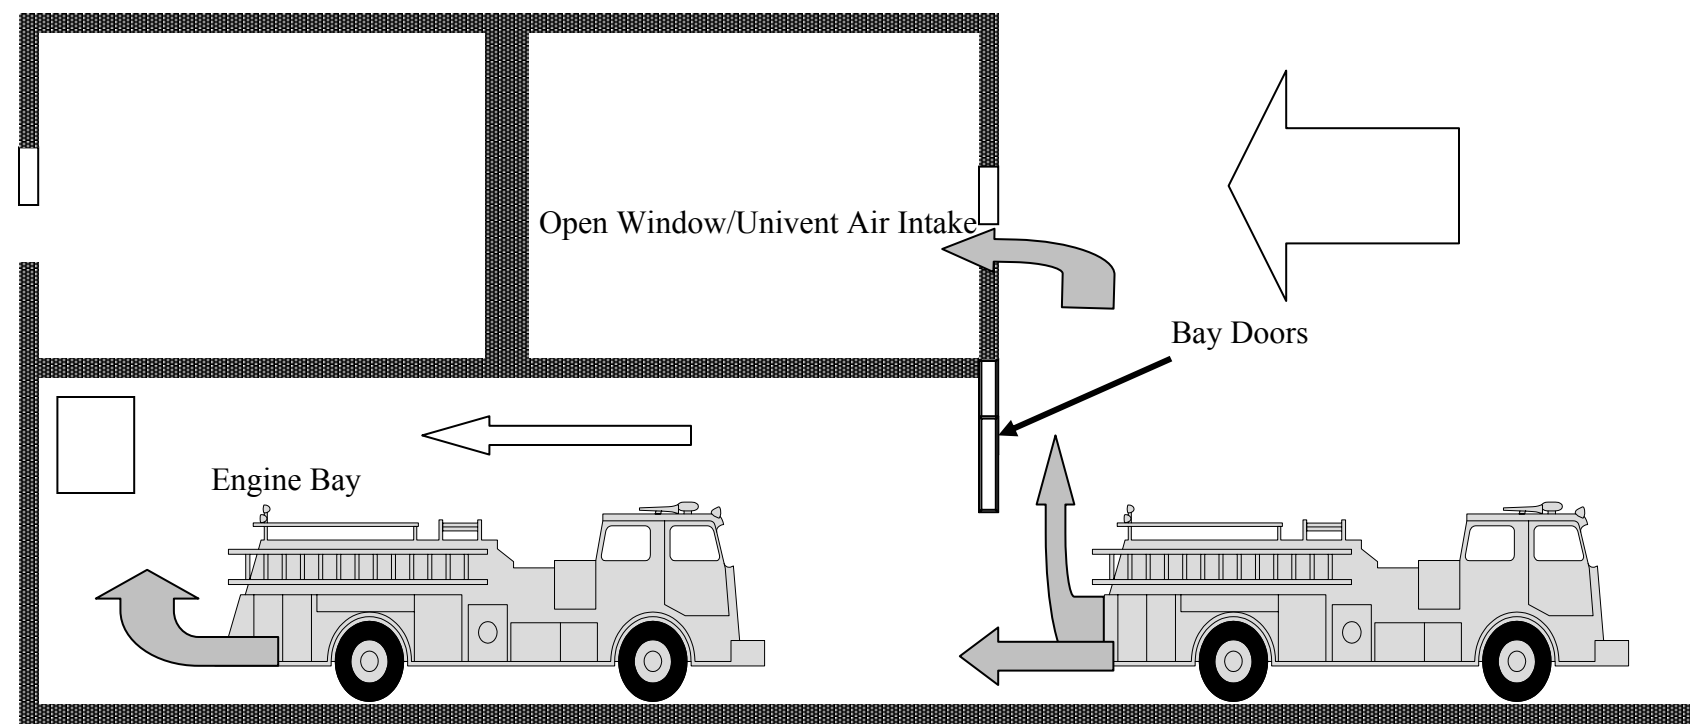
**Figure 2                      Engine Bay & Potential Entrainment of Vehicle Exhaust Through Second Floor Open Windows/Univent Air Intakes**

Univents in second floor offices were in use and windows were open during operation of fire fighting vehicles. Under certain wind and weather conditions exhaust emissions can penetrate or be drawn into the room (called entrainment) through univent air intakes or open windows. Another possible pathway for exhaust emissions is through utility holes. The ceiling/walls of the engine bays are penetrated by holes for utilities. These holes can present potential pathways into occupied areas if they are not airtight. Each of these conditions presents a pathway for air to move from the engine bays to occupied areas of the station. In order to explain how engine bay pollutants may be impacting the second floor and adjacent areas, the following concepts concerning heated air and creation of air movement must be understood.

4. Examine methods to seal spaces and holes around fire poles. Considering contacting the manufacturer for advice.
5. Under certain wind and weather conditions second floor windows should be shut and univents may be temporarily deactivated during engine operation to prevent entrainment of vehicle exhaust.

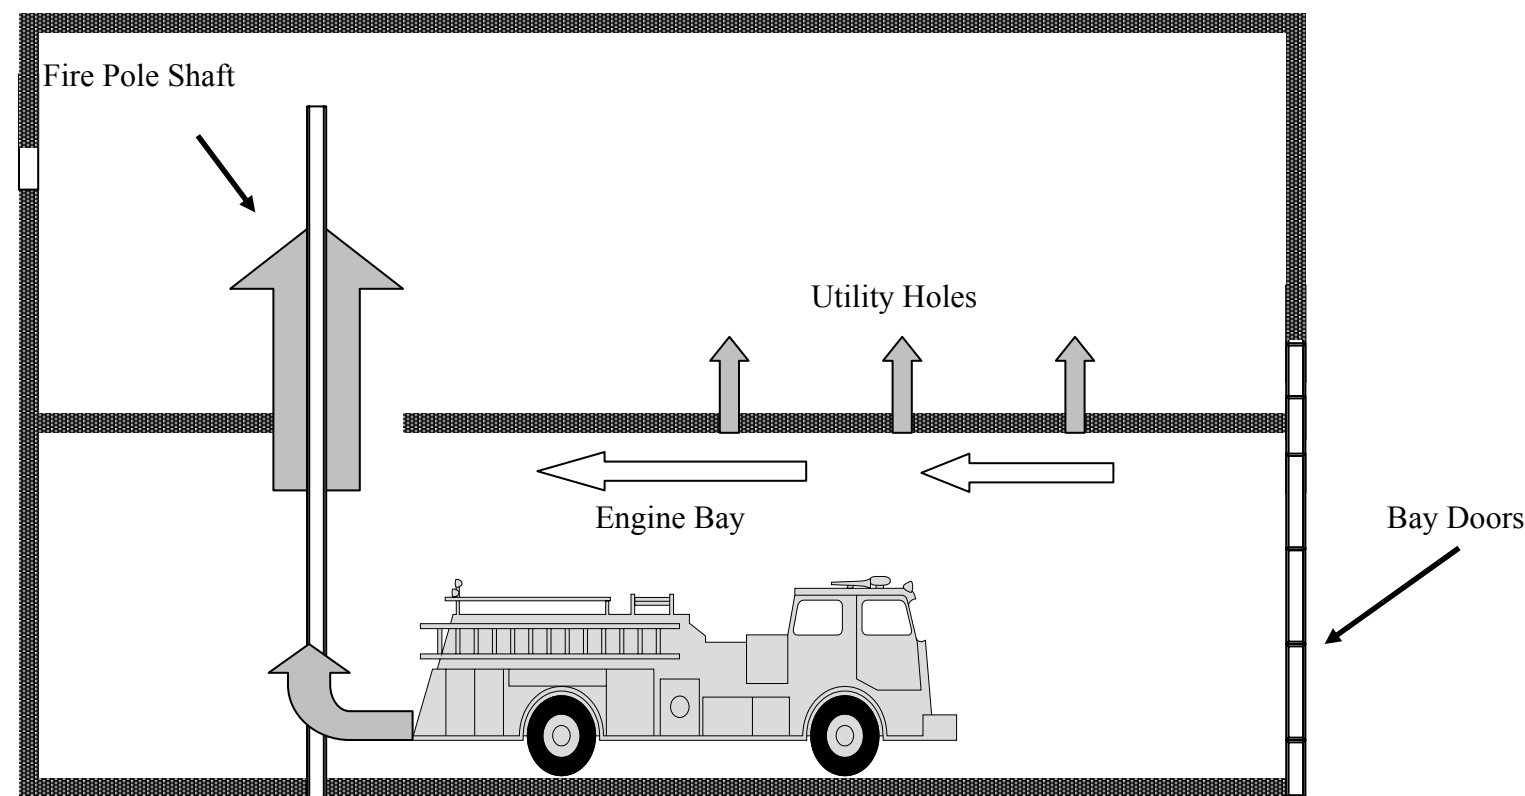
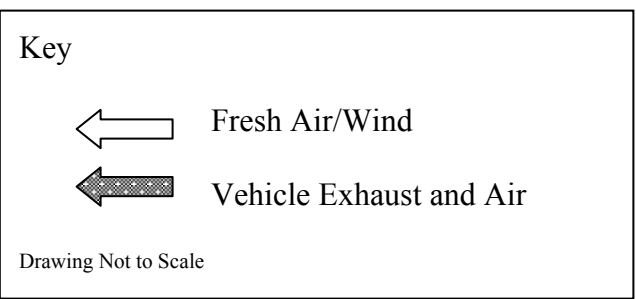
Figure 3

Although the engine bay is equipped with a mechanical ventilation system, a number of pathways for vehicle exhaust and other pollutants to move from the engine bay into occupied areas were identified (see Figures 2 & 3). The stairwell doors (off the engine bay) leading to the upstairs had spaces beneath doors from which light could be seen penetrating (see Picture 16). Clamshells (i.e. closures) around fire poles did not close completely creating spaces (see Picture 17). Elevated levels of UFPs were measured near these areas after operation of fire fighting vehicles (see Tables 2 & 3). These results demonstrate that the breaches are serving as pathways for diesel exhaust and particulates to move from the engine bay into occupied areas of the station.

As motor vehicles operate indoors, the production of vehicle exhaust in combination with cold air moving from outdoors through open exterior doors into the warmer engine bay can pressurize the engine bay. Positive pressure within a room will force air and pollutants through spaces around doors, utility pipes and other holes in walls, doors and ceilings. To reduce airflow into the second floor, sealing of these pollutant pathways should be considered.

2. Keep all doors and windows accessing engine bays closed at all times.
3. Ensure doors around engine bay fit completely flush with threshold. Seal doors on all sides with foam tape, and/or weather-stripping. Consider installing weather-stripping/door sweeps on both sides of doors with access to the engine bay to provide a dual barrier. Ensure tightness of doors by monitoring for light penetration and drafts around doorframes.

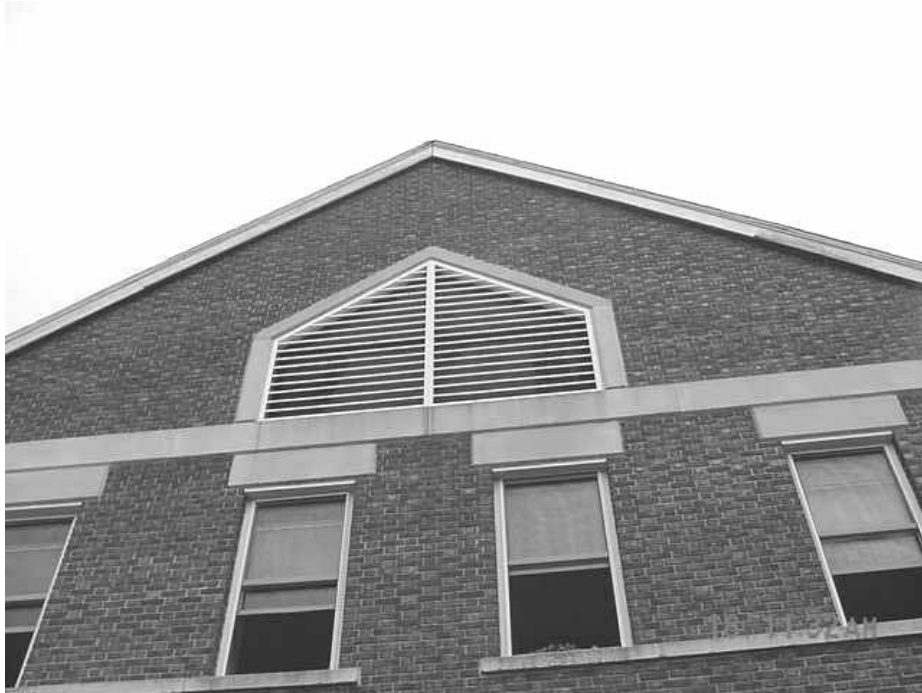
**Picture 1**

million (ppm) in all areas surveyed, which indicates adequate air exchange by the ventilation system. Ventilation is provided to interior rooms by several air handling units (AHUs) located in the attic. AHUs introduce fresh air into the system through intake vents on the roof (see Picture 1). The amount of outside air introduced is controlled by an actuator connected to intake louvers (see Picture 2). Conditioned air is delivered via ducted wall or ceiling mounted air diffusers. Return vents in the main hallway and common areas (see Picture 3), draw air back to AHUs via ductwork. These systems were in operation during the assessment. WFD officials who were present and asked were not aware if a preventative maintenance program was in place for air handling equipment.

**Outside Air Intake for Attic Air Handling Equipment**

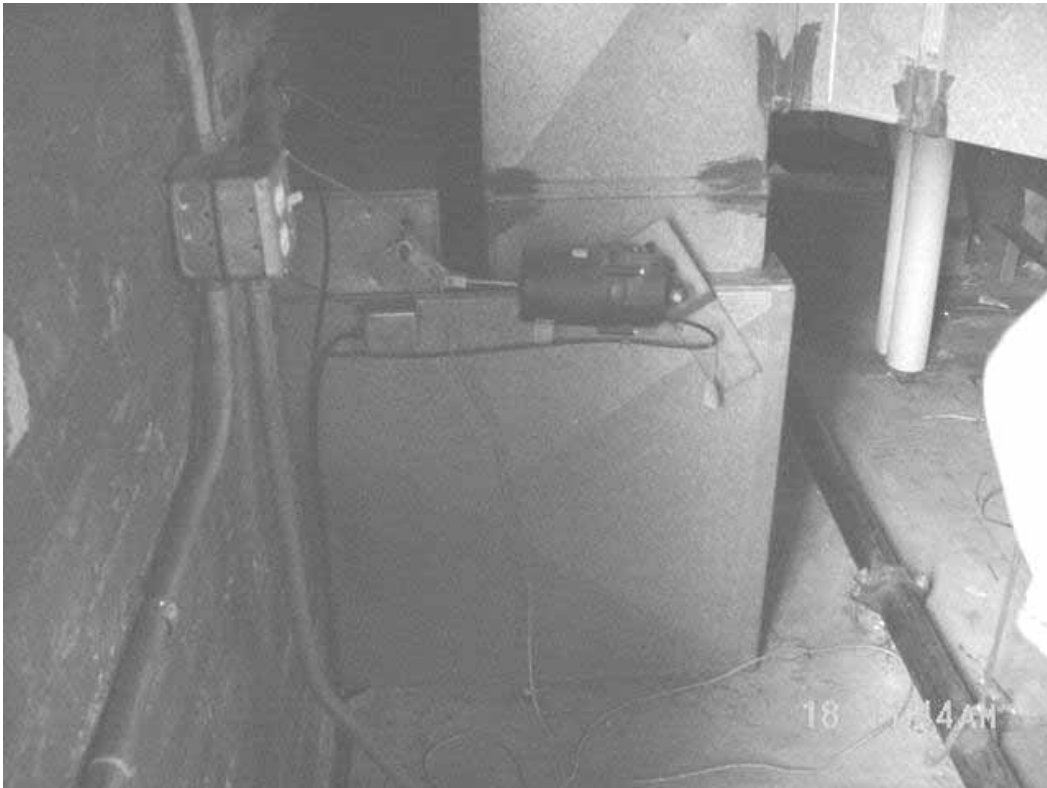
**Picture 2**

**Actuator in Attic Controlling Outside Airflow into Attic AHUs**

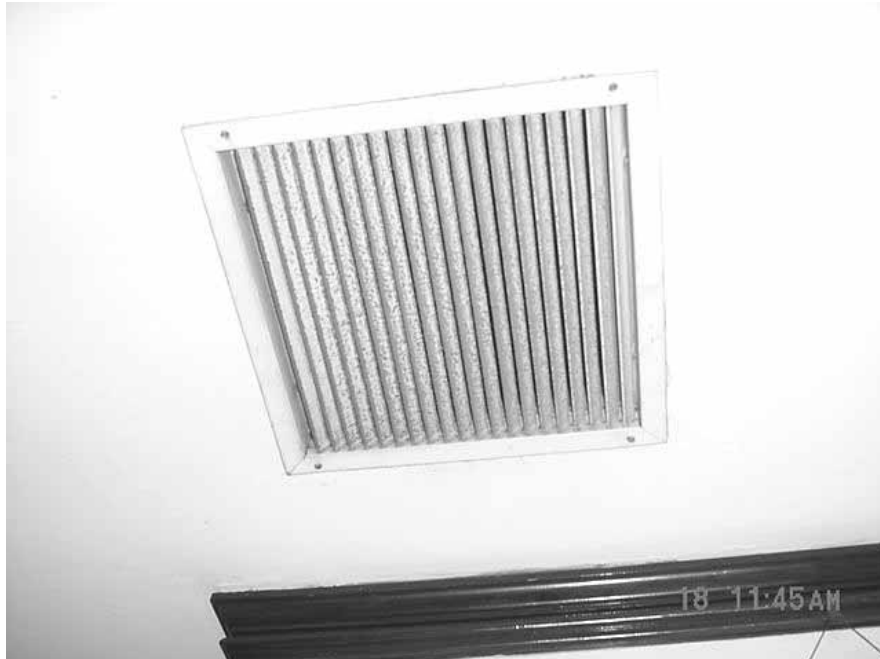
**Picture 3**

**Ceiling-Mounted Return Vent**

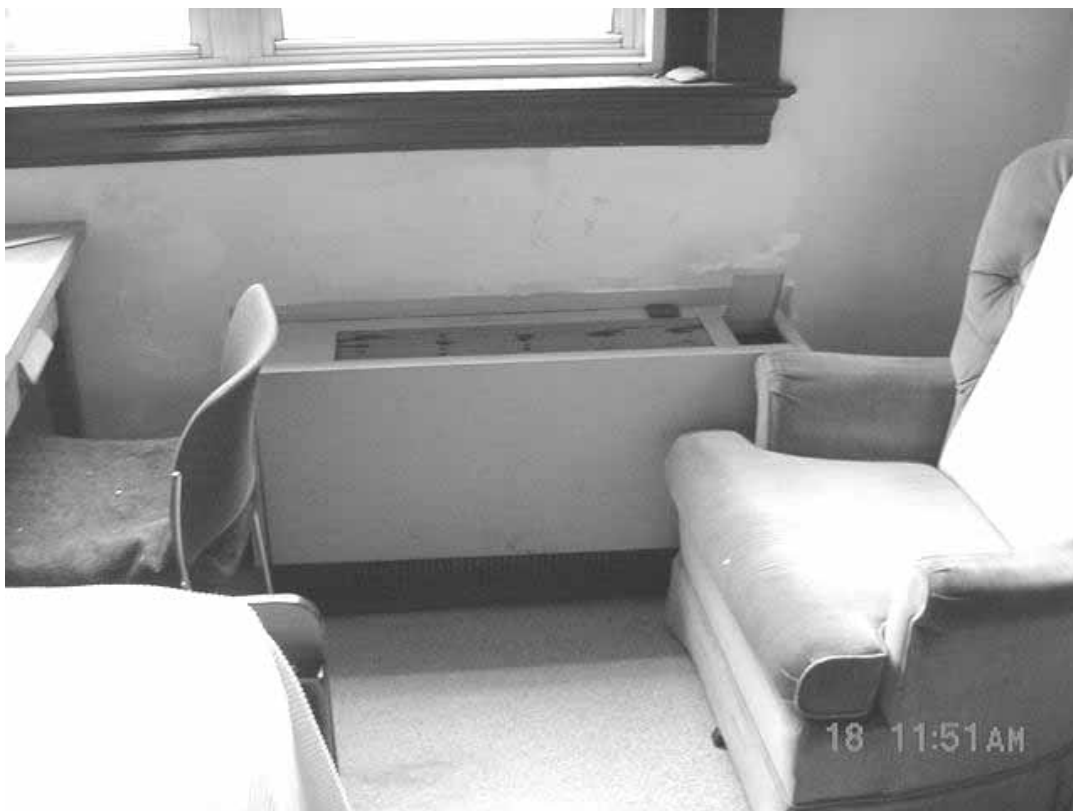
**Picture 4**

Ventilation for perimeter rooms (e.g. berthing areas and offices) is provided by unit ventilators (univents) (see Picture 4). Univents draw air from outdoors through fresh air intakes on exterior walls of the building (see Picture 5) and return air through air intakes at the base of each unit (see [Figure 1](#)). Fresh and return air are mixed, filtered, heated and provided through fresh air diffusers in the top of the units. A number of univents were deactivated during the assessment. Therefore no means of mechanical fresh air was being provided to these areas.

**Univent in Berthing Area**

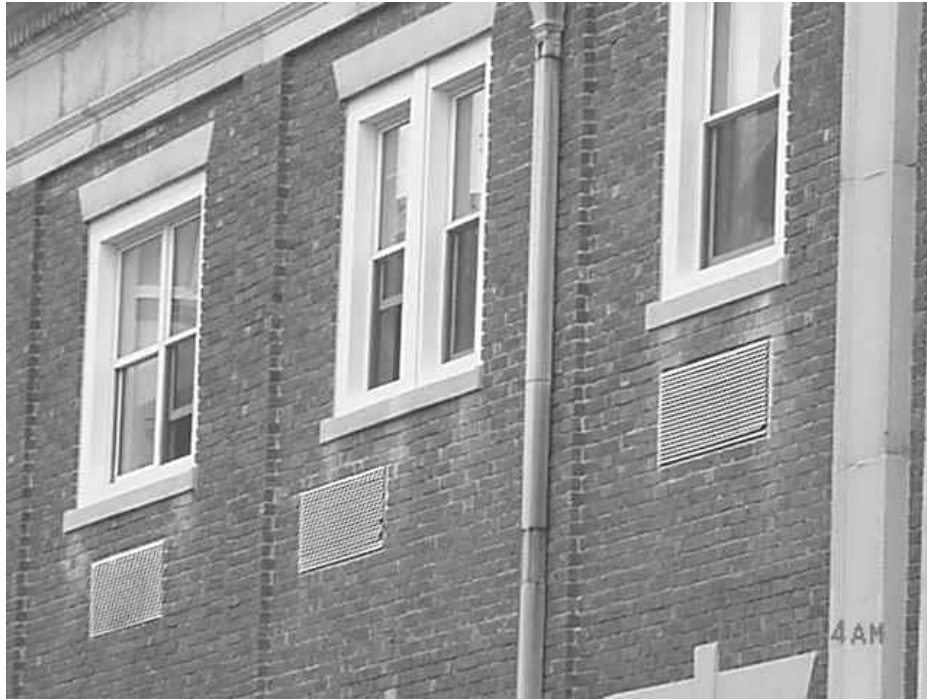
**Picture 5**

**Fresh Air Intake Grills for Fan Coil Units**

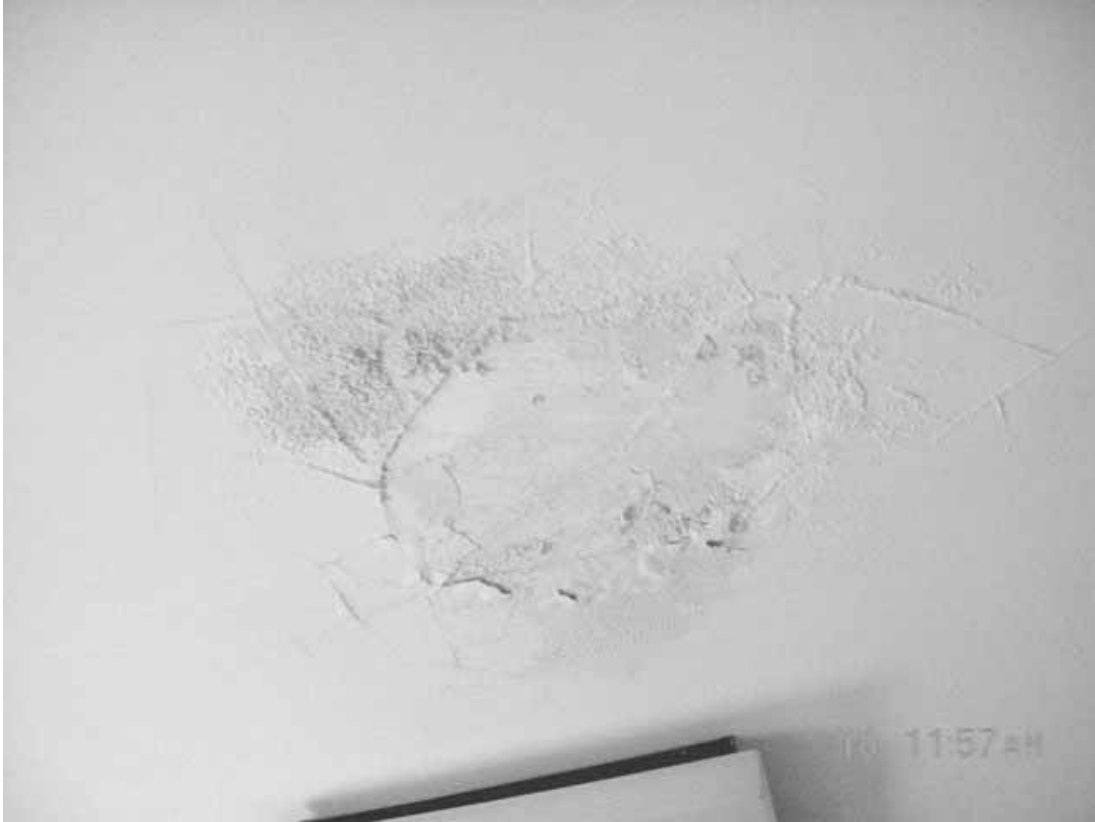
**Picture 6**

The building has experienced problems with water penetration, most notably on the second floor. Throughout the building water leaks were evidenced by water damaged plaster on walls, stained ceiling tiles, peeling paint and efflorescence (see Pictures 6-8). Water-damaged ceiling tiles can provide a source of mold and should be replaced after a water leak is discovered and repaired. Efflorescence is a characteristic sign of water damage to building materials such as brick or plaster, but it is not mold growth. As moisture penetrates and works its way through mortar around brick, water-soluble compounds dissolve, creating a solution. As the solution moves to the surface of the brick or mortar, water evaporates, leaving behind white, powdery mineral deposits. This condition indicates that water from the exterior has penetrated into the building.

**Water Damage Ceiling Plaster**

13. Replace/repair water-damaged ceiling tiles and wall plaster. Examine the area above and behind these areas for microbial growth. Disinfect areas of water leaks with an appropriate antimicrobial.

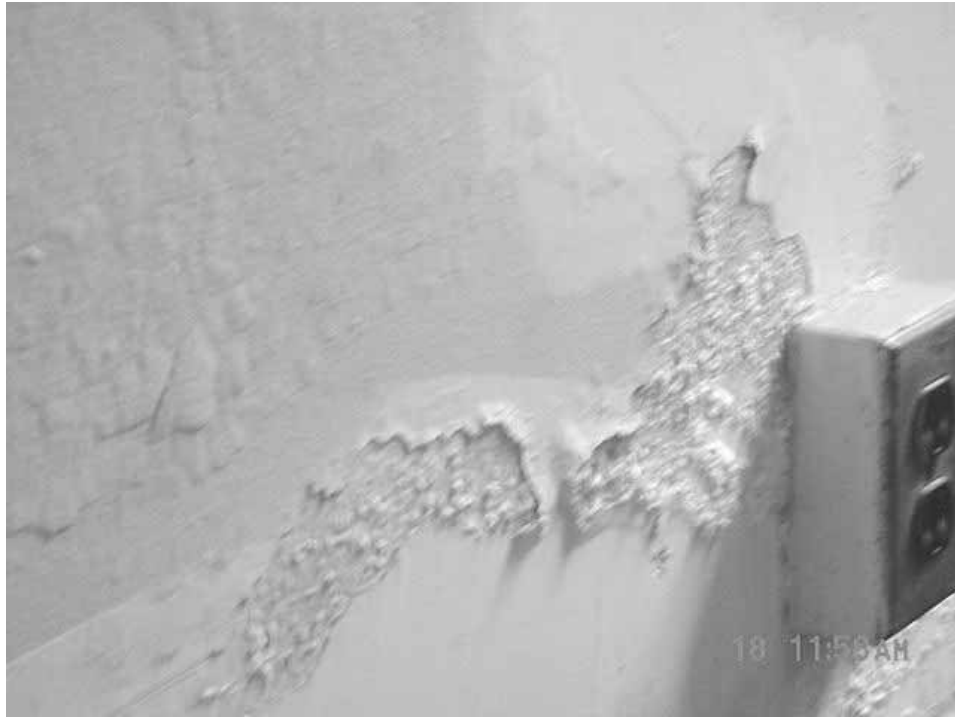
**Picture 7**

**Water Damaged Wall Plaster and Efflorescence**

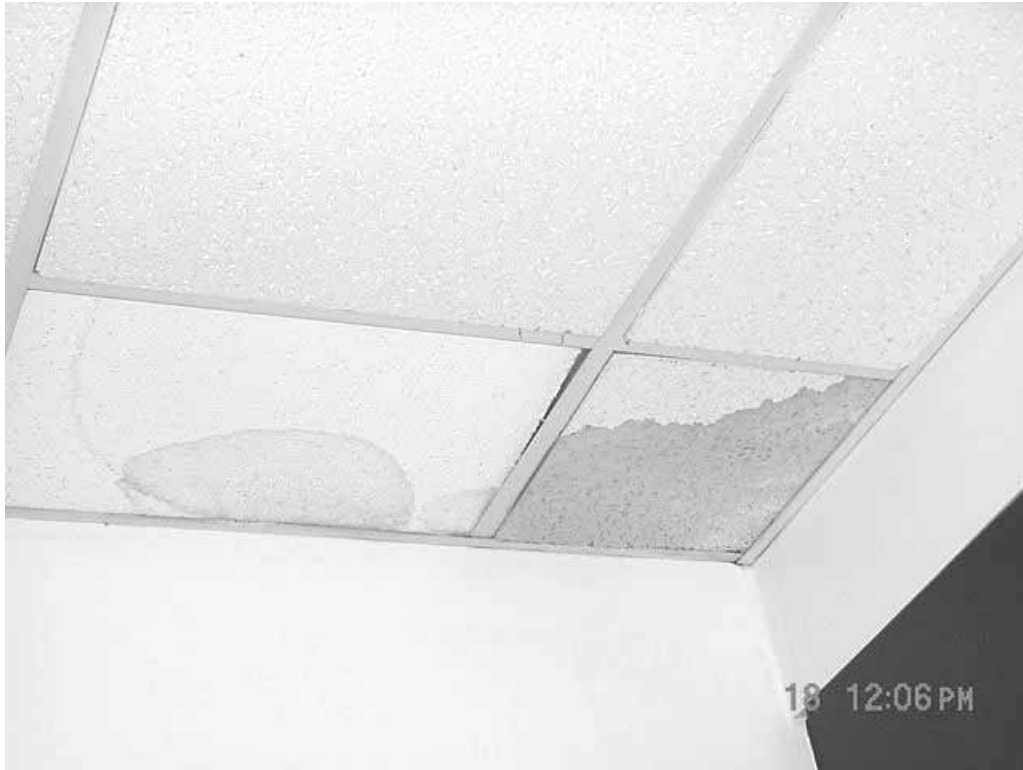
**Picture 8**

**Water Damaged Ceiling Tiles**

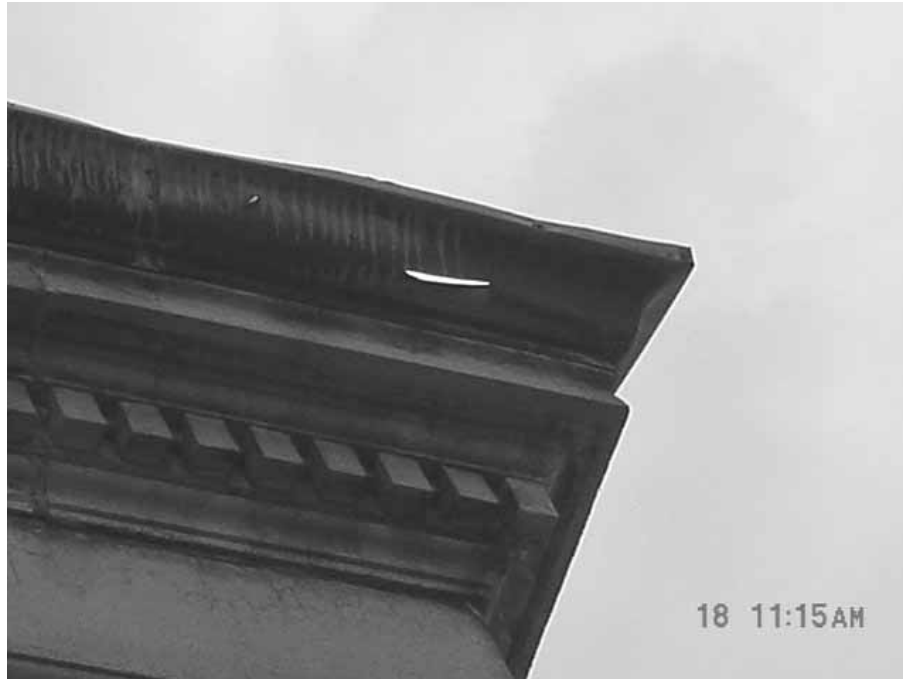
**Picture 9**

- Breaches/holes were observed in the gutter/downspout system (see Pictures 9 & 10).  
Lack of proper roof drainage can allow rainwater to run down the side of the building and pool on the ground at the base of the building against exterior walls. The freezing and thawing action of water during winter months can create cracks and fissures in the foundation.
- Small trees/shrubs and other plants were seen growing in close proximity to the exterior of the building (see Picture 11). The growth of roots against the exterior walls as well as spaces between the tarmac and exterior walls of the building can bring moisture in contact with wall brick and also lead to cracks and/or fissures in the foundation below ground level.
- Missing/damaged mortar around brick and an open utility hole were observed on the exterior of the building (see Pictures 12 & 13).

**Hole in Gutter System**

14. Replace or repair damaged gutters and downspouts.
15. Remove plants from the wall/tarmac junction around the perimeter of the building.
16. For further building-wide evaluations and advice on maintaining public buildings, see the resource manual and other related indoor air quality documents located on the MDPH's website at <http://www.state.ma.us/dph/beha/iaq/iaqhome.htm>.

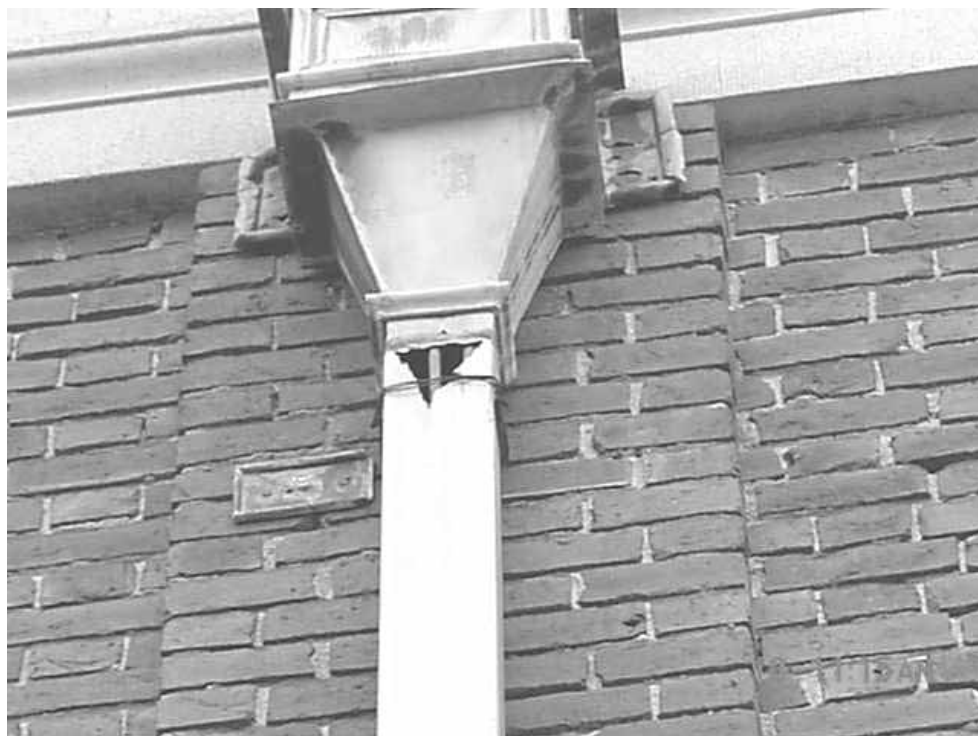
**Picture 10**

**Breach in Downspout**

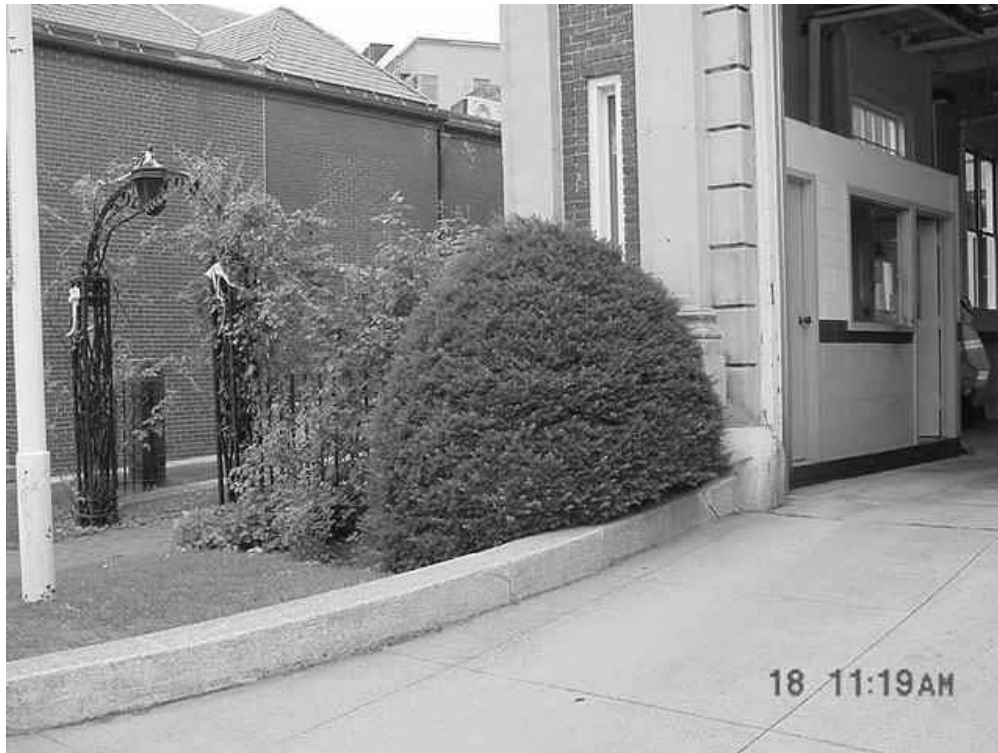
**Picture 11**

**Shrubbery/Plants Growing Against Building**

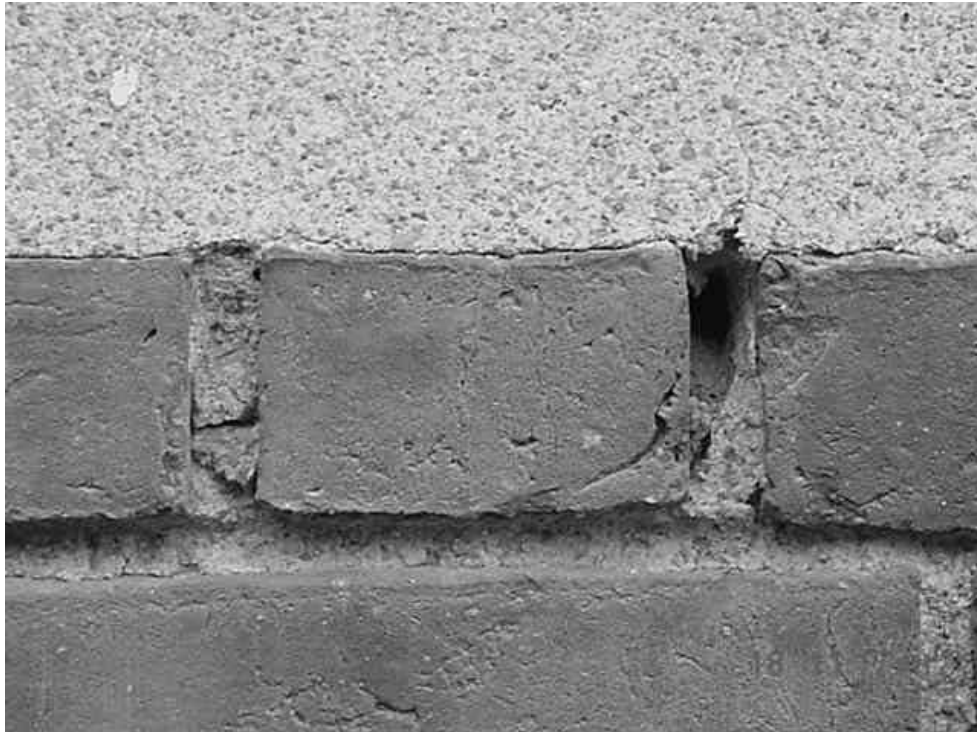
**Picture 12**

**Missing/Damaged Mortar**

12. Continue with plans to conduct building envelope study, to determine current conditions and future improvements to address water penetration issues.

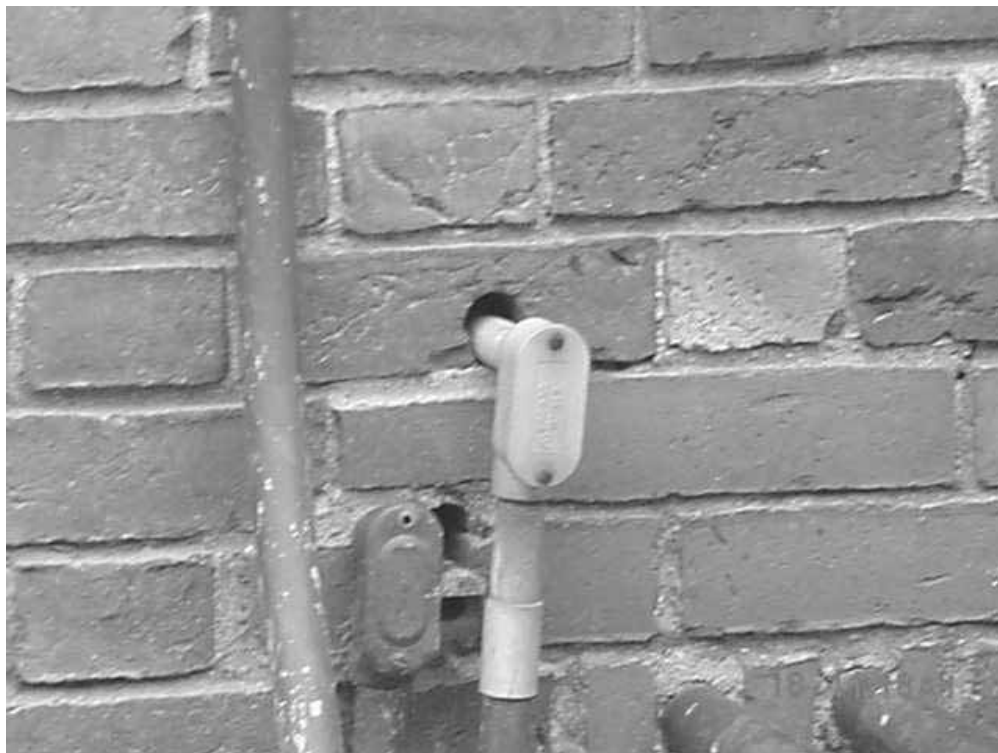
**Picture 13**

**Open Utility Holes in Brick**

6. Ensure all utility holes are properly sealed in both the engine bay and their terminus to eliminate pollutant paths of migration.

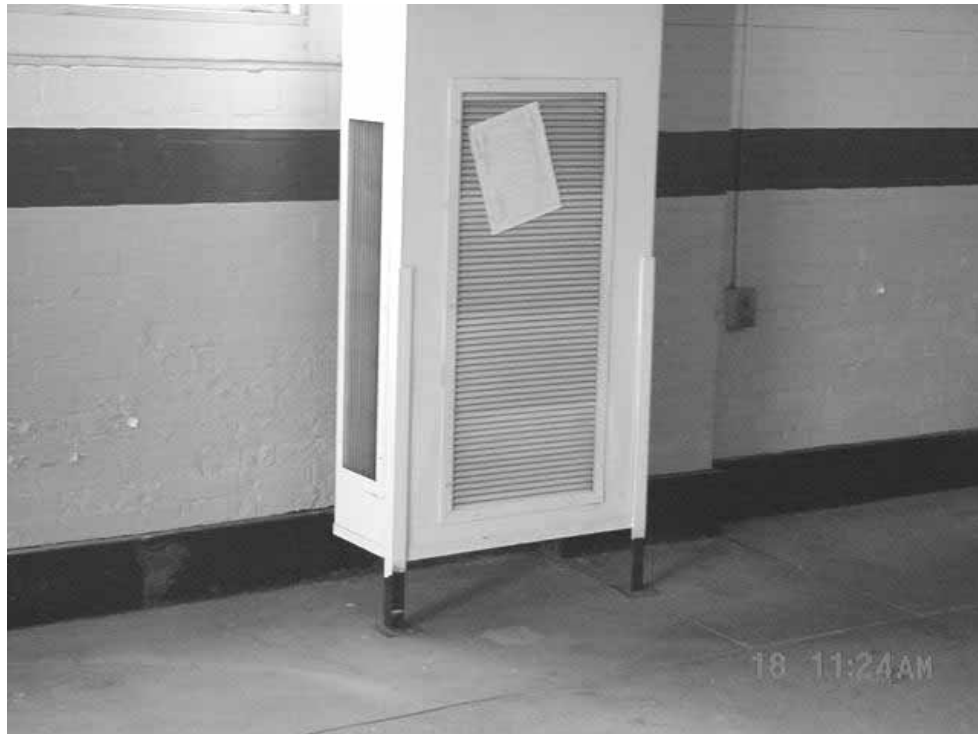
**Picture 14**

As mentioned previously, the station is equipped with a mechanical exhaust system to remove exhaust from the engine bay during vehicle idling. The system consists of a large exhaust vent located at floor level on the West side of the engine bay (see Picture 14). Fire

**Exhaust Vent on West Side of Engine Bay**

1. Continue to operate the engine bay vent system on a continuous basis to create negative pressure in the engine bay. Consider installing an automatic control to activate the engine bay exhaust system as engine bay doors open.

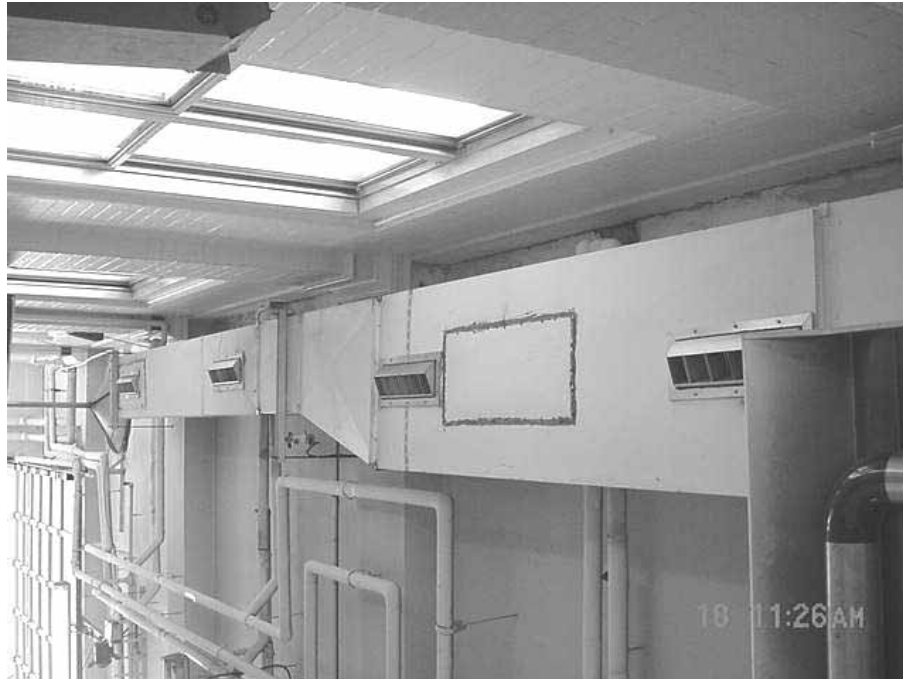
**Picture 15**

Department personnel reported that several make up air vents were retrofitted on the East side of the engine bay (see Picture 15), to pressurize the engine bay toward the exhaust vent. This system is reportedly in operation 24 hours a day.

**Retro-fitted Supply Vents on East Side of Engine Bay**

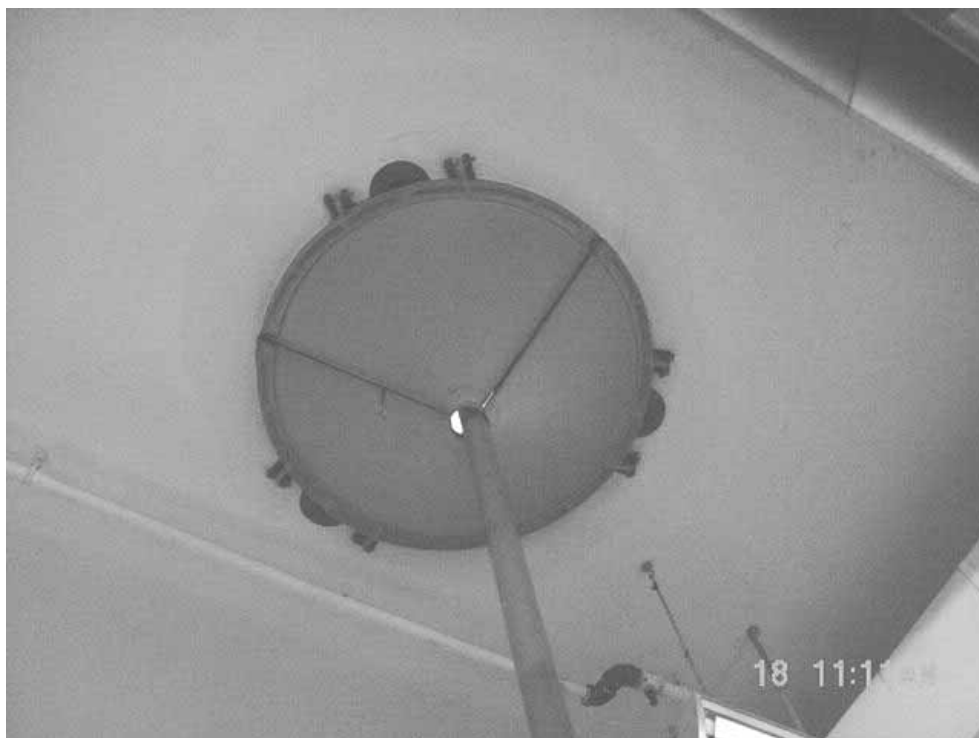
**Picture 17**

**Hole/Spaces around Fire Pole**

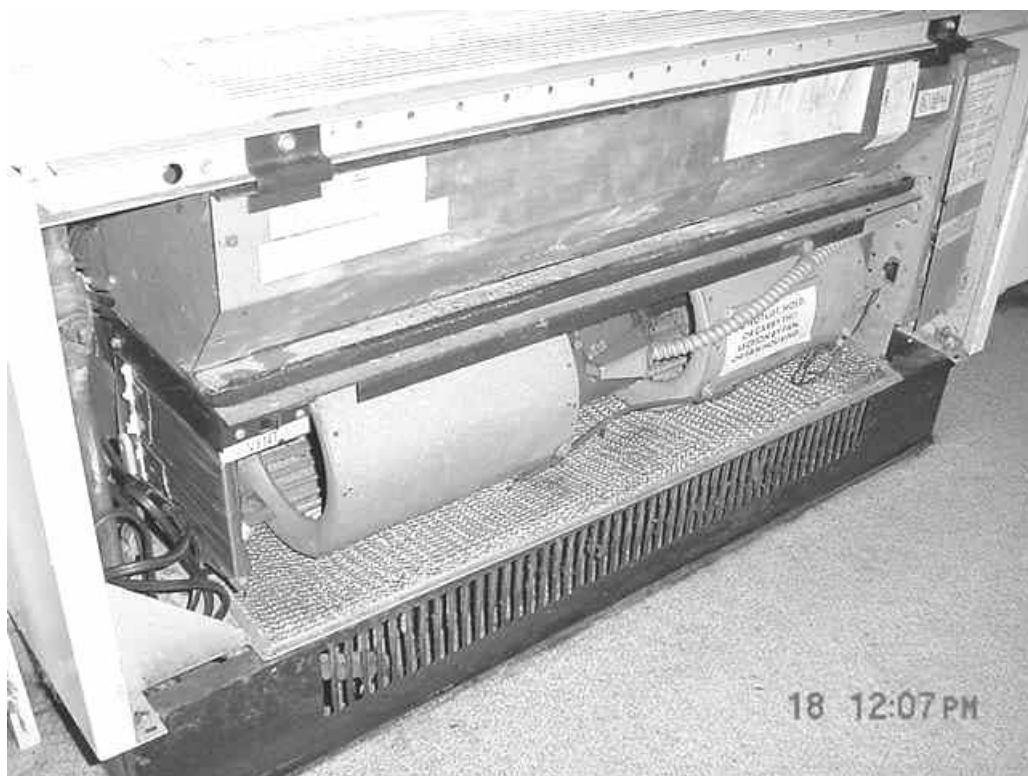
**Picture 18**

As discussed, WFD staff could not identify the last date of preventative maintenance done on air handling equipment. The access panel for the AHU filters in the attic could not be located; therefore the condition of filters could not be examined. Filters in univents were examined and are made of a metal mesh material (see Picture 18). This type of filter provides minimal respirable dust filtration and must be physically cleaned by hand. In order to decrease aerosolized particulates, disposable filters with an increased dust spot efficiency can be installed. The dust spot efficiency is the ability of a filter to remove particulates of a certain diameter from air passing through the filter. Filters that have been determined by ASHRAE to meet its standard for a dust spot efficiency of a minimum of 40 percent would be sufficient to reduce airborne particulates (Thornburg, D., 2000; MEHRC, 1997; ASHRAE, 1992). Note that

**Metal Mesh Filter in Univent**

increased filtration can reduce airflow produced by the univent through increased resistance (called pressure drop). Prior to any increase in filtration, each piece of air handling equipment should be evaluated by a ventilation engineer to ascertain whether they can maintain function with more efficient filters.

7. Work with Winchester town officials to develop a preventative maintenance program for all HVAC equipment department wide.
8. Change filters for HVAC equipment as per the manufacturer's instructions or more frequently if needed. Examine HVAC equipment periodically for maintenance and function. Examine the feasibility of upgrading filters.
